## **The Environmental Impact of increasing Boat access to the Peel- Harvey Estuary with particular reference to the effect of Hull type, draught and displacement.**

By Peter H Forrest. (July 2012)

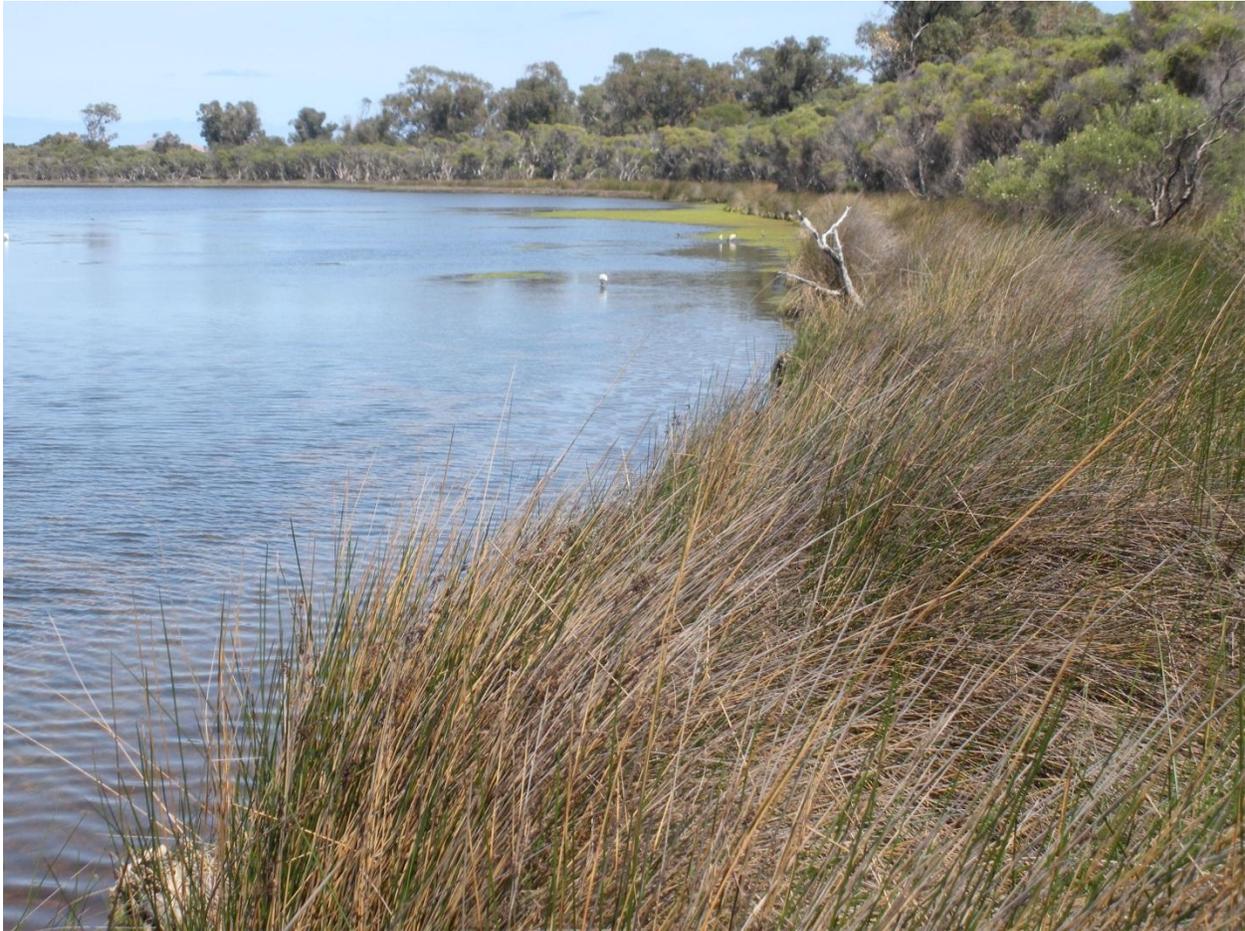
Frame 1

This is a typical example of the original reed bed fringe, backed by low scrub and then trees – that surrounds the Peel-Harvey Estuary - in areas where power boats have **not** been able to get close to the shore-line (and exposure to increasing salinity has not yet taken effect).

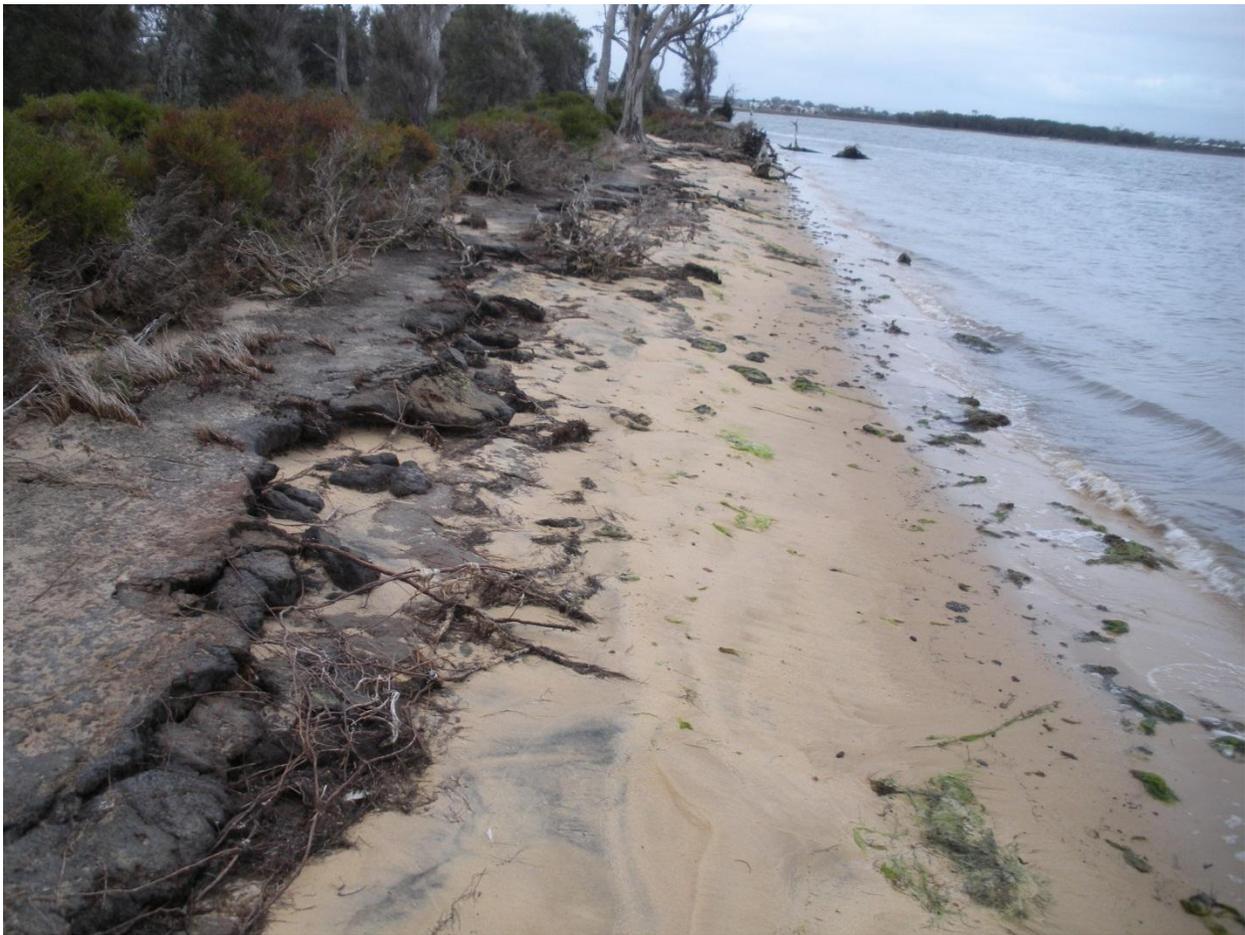
Frame 2.

This shoreline was previously and originally exactly similar to the previous photograph (Mandurah Quay shoreline). Note the reed bed has now been wiped out completely by repeated wash from power boat use in the adjacent channel (and the locally increased salinity).

The thin sand covering through which low samphire was also previously growing behind the reed bed has also been washed away. Note the black mud on the left that was under the thin sand foundation of the reed bed (this combination extends throughout the Estuary) has also been broken through then exposed and hardened by exposure to air and sun.

The remaining low scrub vegetation mixed with some taller mature Samphire, is now under attack. With the reed bed and the low Samphire gone, the foreshore has been destroyed now as far back as very close to the tree line.

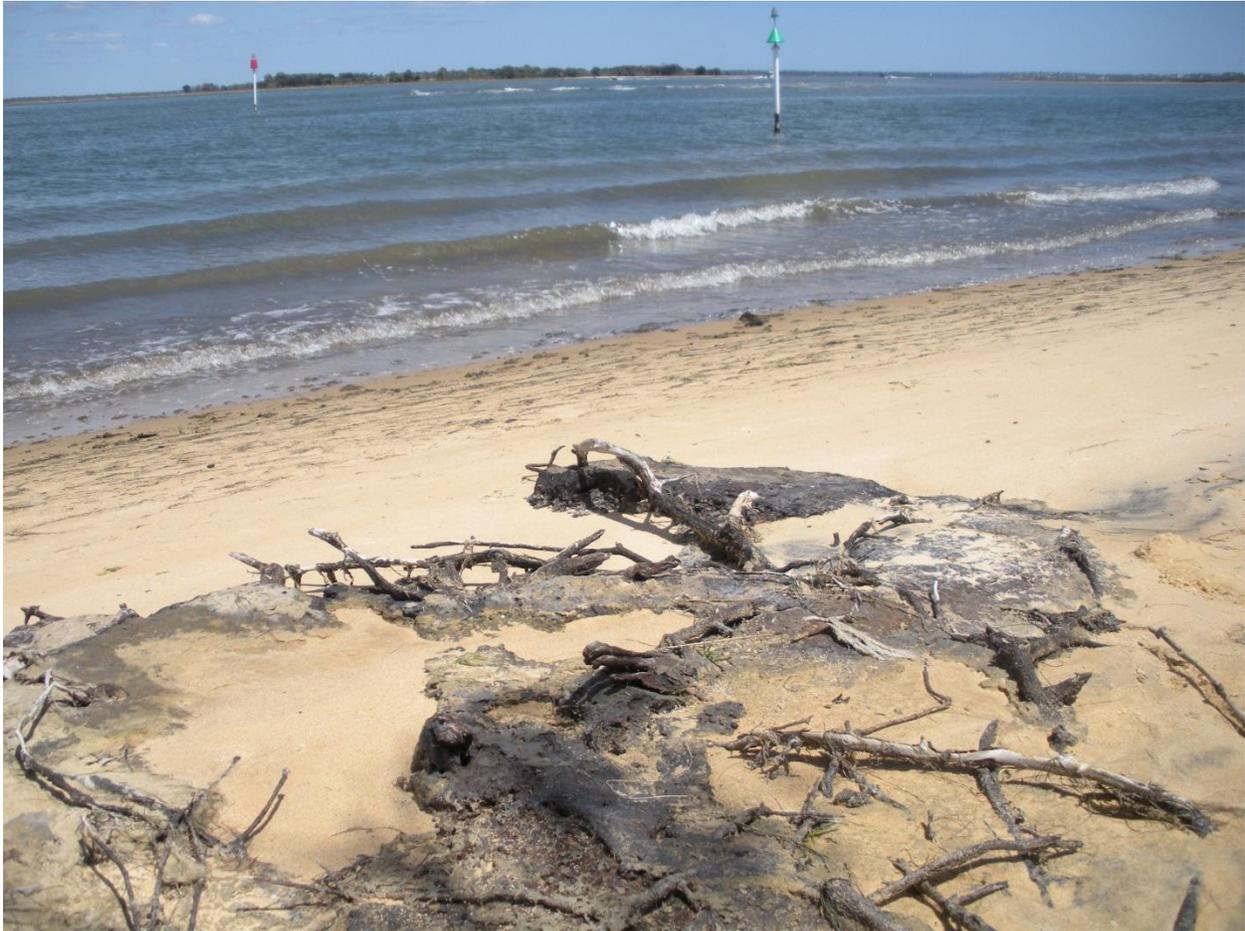
Frame 3.

Mandurah Quay shoreline again (location close to Frame 3 above) – note the channel markers indicating very close proximity of the inshore branch from the Sticks Channel and the wave-wash from only a small 5metre power boat that has just passed by, probably observing the current 8 knot speed limit.

These waves are multiplied in height and intensity according to increased size and displacement of power boats allowed to enter.

The low breaking waves seen behind and adjacent to this inner channel, indicate zero water depth very close to the line of the southern end of the current Sticks Channel. Already in summer season some 40 power boats of various sizes, pass this vicinity per hour and cause massive water turbulence over a wide area of the shallow water-bed, as well as multiple wave erosion on the shoreline.

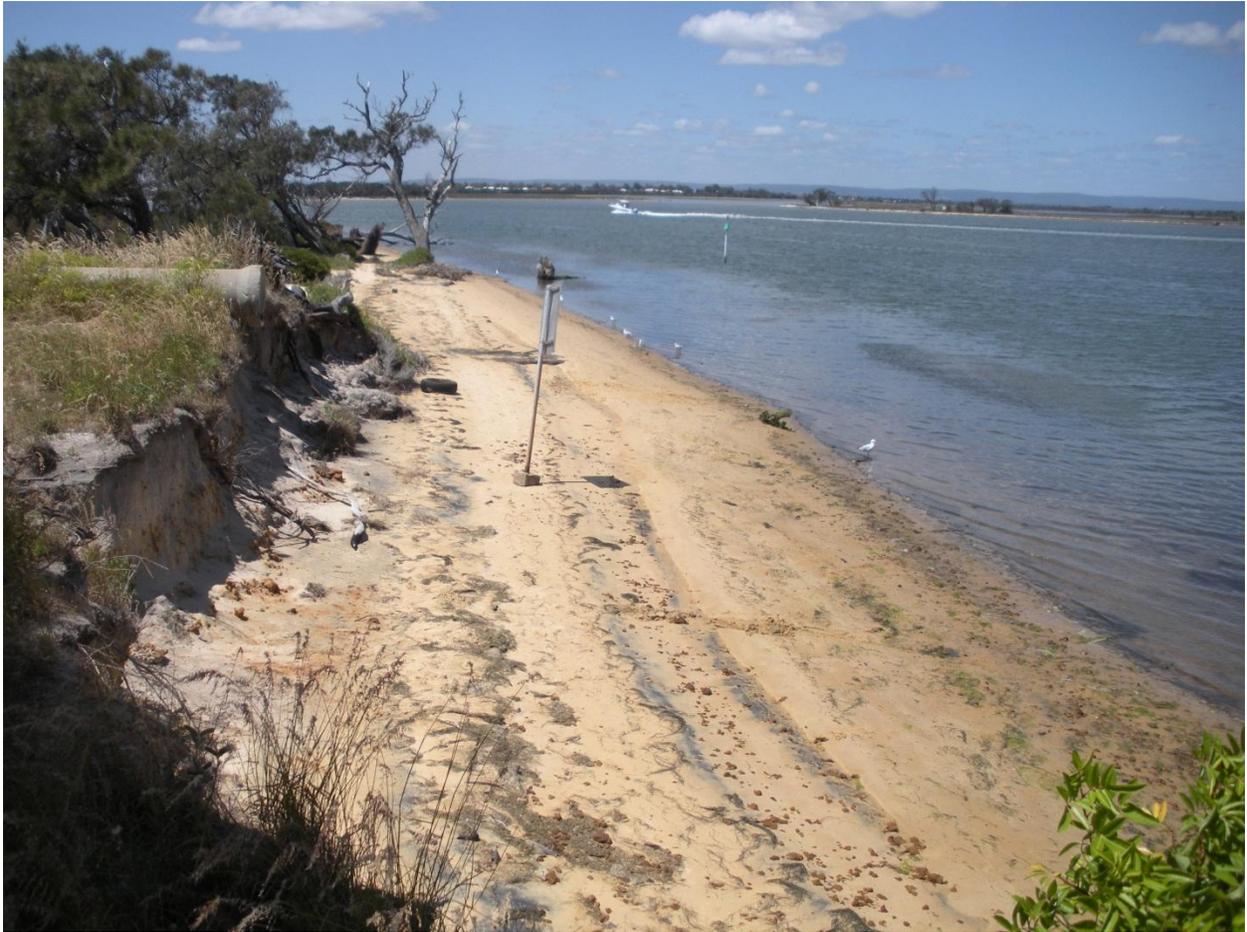
Frame 4.

More of e.g. Mandurah Quay shoreline showing gross erosion through power-boat proximity.

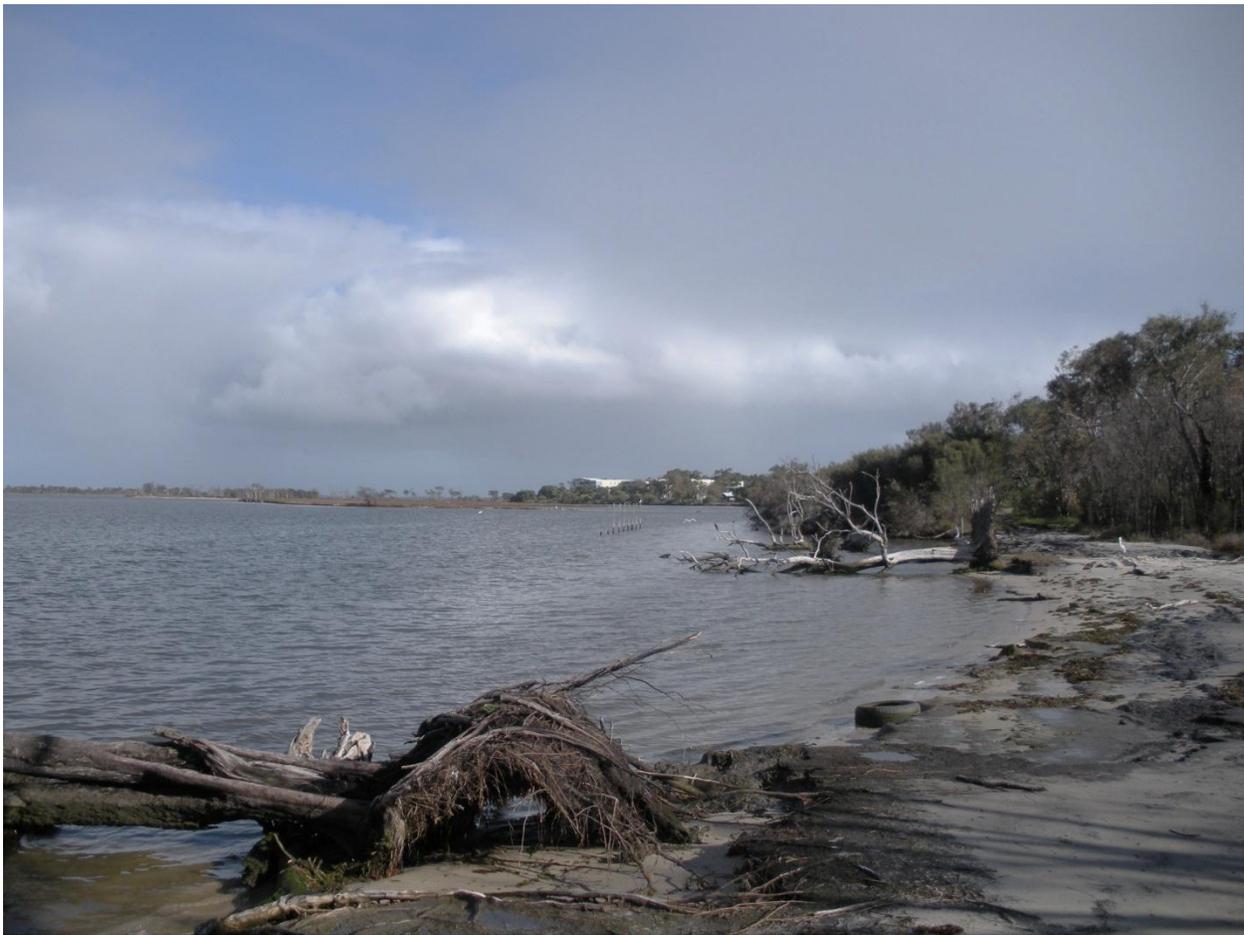
Frame 5.

In this photograph the fringe vegetation has been obliterated altogether back to and even through the remaining tree line.

This example shows the Peel-Harvey Estuary fringe where power boats are permitted to pass relatively close to the shoreline (this foreshore is adjacent to the Sticks Channel, that is dredged to 1.4 metres i.e. 1.4 metres is the general low water depth of the Estuary).

Note that repeated Boat wash has torn up the reed bed and also washed away large quantities of the thin sand cover then removed the low scrub and then undermining fringe trees altogether. – Note the remnants of the black mud that was previously covered by reeds is now exposed and hardening with exposure to the air and sun.

If power boat use is allowed to continue increasing at the present rate and even larger boats are permitted to enter (as proposed close to Point Grey) this drastic erosion of shoreline (that is also being exacerbated by increased salinity) - complete removal of the smaller water-bird

habitat will become typical and is completely unacceptable in the Peel-Harvey Estuary and connected waterways.
